SUBJECT: IFS Ball Joints

CONDITION: The central steering system ball joints may not have been properly torqued or secured into the pitman arms.

APPLIES TO: This bulletin applies to IFS models 1660S3, 1800S3, 2000S3, and 20S3

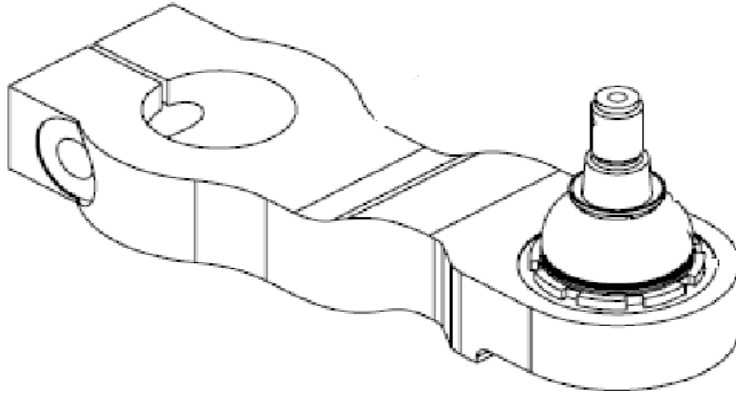
FIG. 2-1

1. Follow normal maintenance and safety procedures to gain access to the pitman arm
Refer to FIG. 2-1.

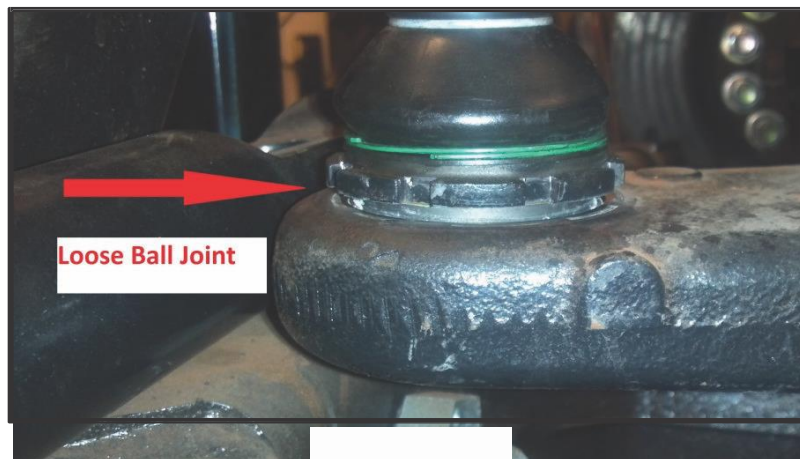
2. Visually inspect the ball joint located in pitman arms. The ball joint shall be fully engaged with the notched flange in contact with the surface of the pitman arm. If it is not, please proceed to the repair procedure. Refer to FIG. 2-2 and 3-1. (**Images may not exactly represent your suspension**)

3. If the ball joint appears to be seated, using a .001" feeler gauge to check under the notched flange. If the feeler gauge slides under the flange, please proceed to the step by step instructions.
4. With a punch and hammer use moderate force in an effort to tighten the ball joint in place. If it moves proceed to the step by step instructions. If it is tight this will finish the inspection and vehicle can be returned to service.

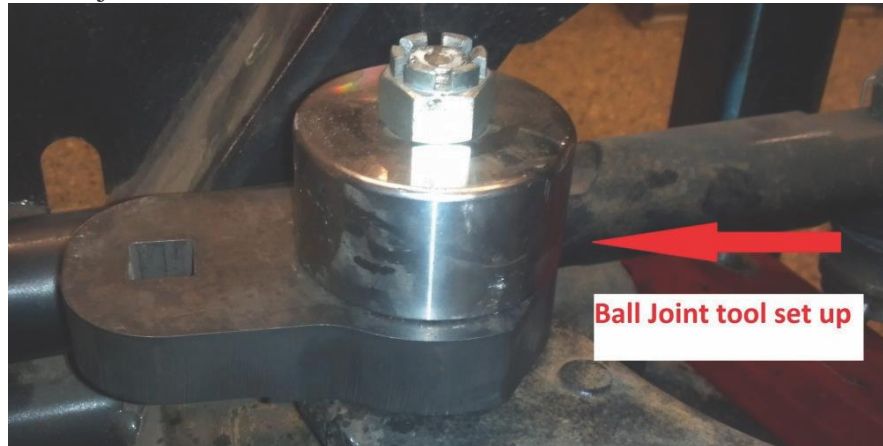
5. Use tools and tighten ball joint to 350 lbs. ft. with tool 708116-02 at 90 degrees angle to torque wrench. Note: that tool 708116-05 is used with castle nut to hold tool 708116-02 loosely on the ball joints.

6. If torque above is achieved and the ball joints seats in place, re-install the relay rod, tighten castle nut to 155 lbs. ft., and re-install cotter pin and properly bend pins.
